POPPLETON HISTORIC STUDY

B-2652

<u>Block</u>	<u>Lot</u>	<u>Address</u>
219	48-51	40-46 S. Poppleton Street

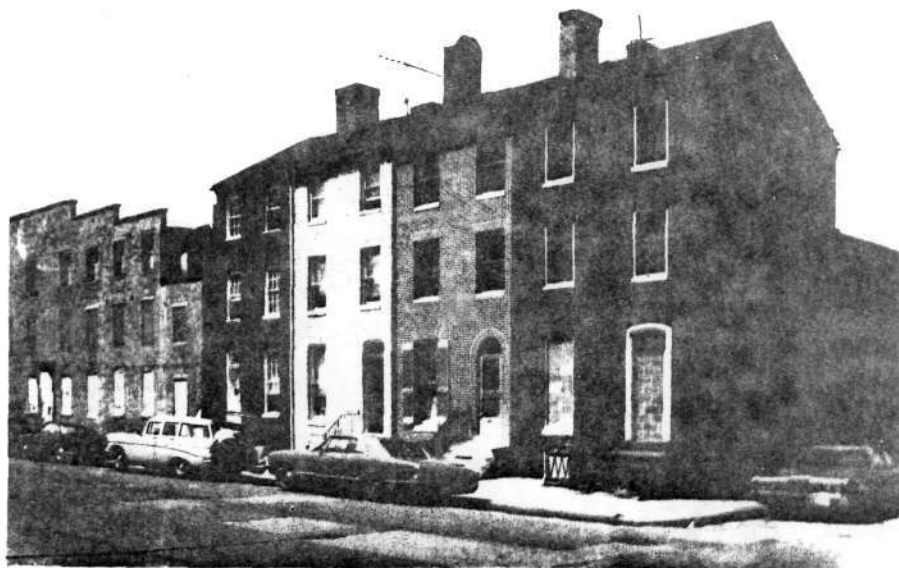
Number 40 is vacant; it has some nice iron work of two periods, the railing c. 1845, the steps c. 1865, which should be protected. Number 46 has wall cracks but seems to be maintained quite well. Number 44 is formstoned and in good to fair condition. Number 42 has a remodelled front, new windows and arched door, which may or may not be original; it is done in good taste and excellent maintenance.

Number 40 blocked up and in bad condition. School buildings and yard behind it. Street needs trees. Across-street are houses.

A nice group. Number 40 should be rehabilitated.

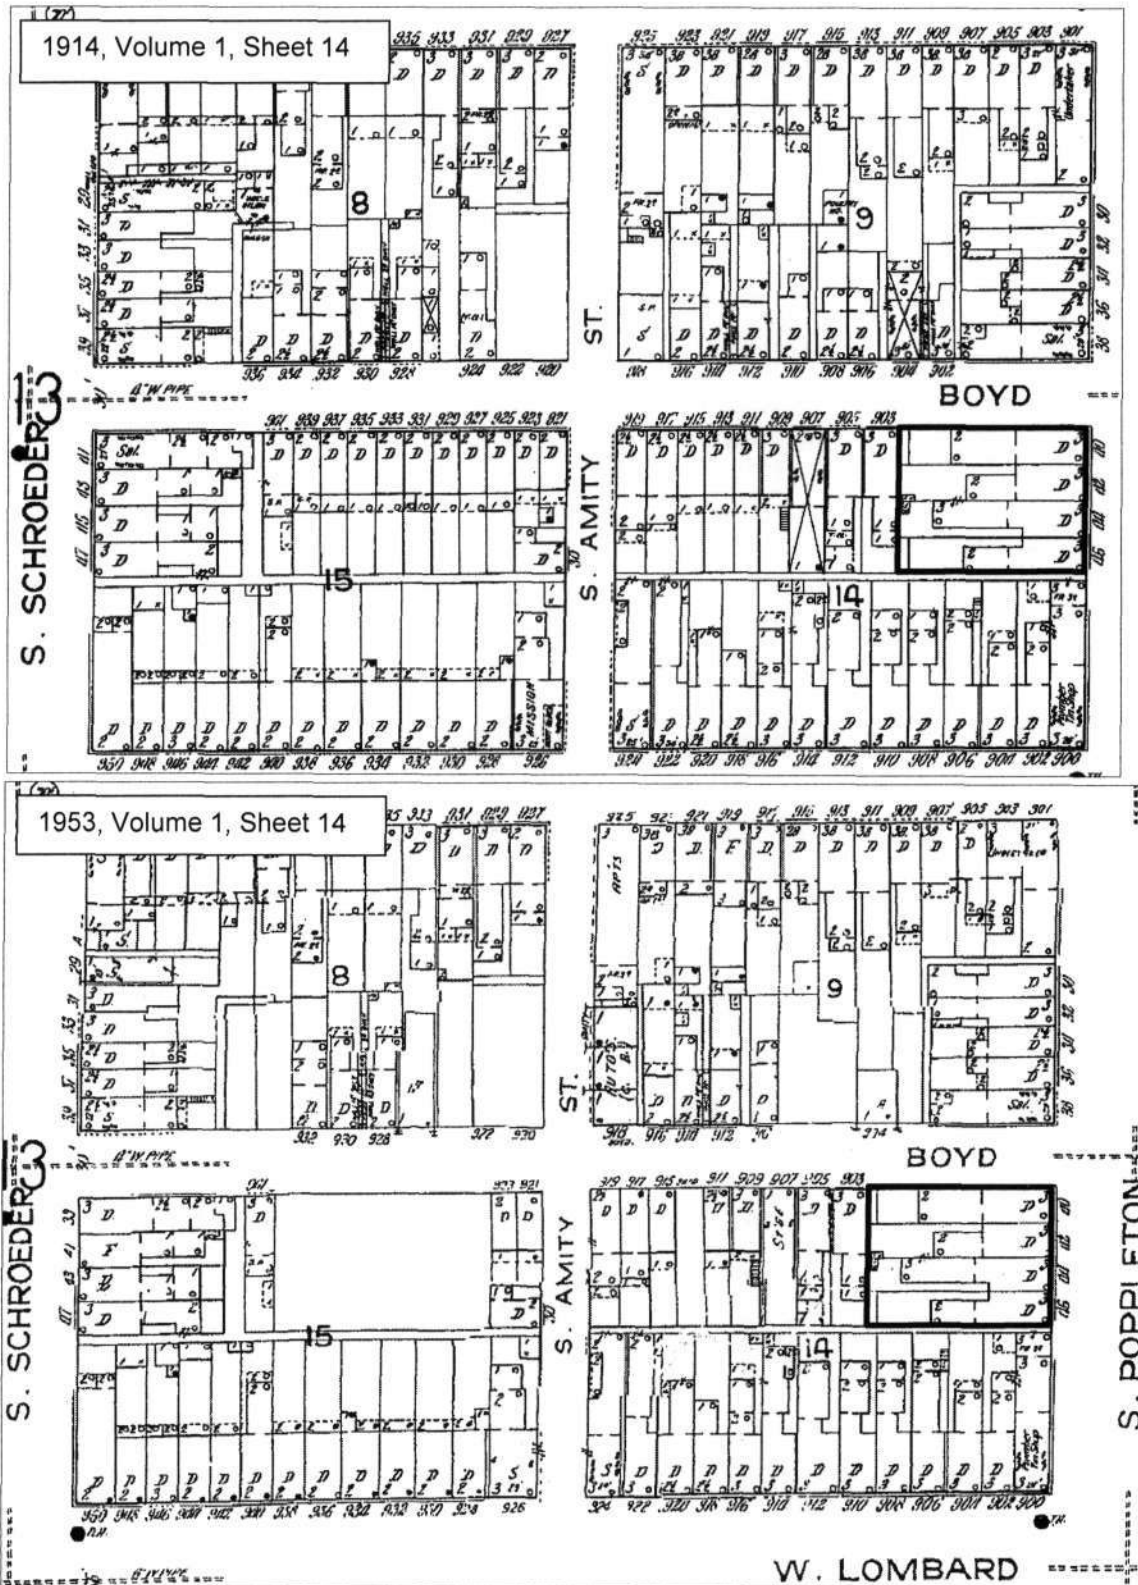
B-2652

40-46 S. Poppleton Street (44-46 demolished)
Sanborn Maps
